AERIAL PHOTOGRAPHIC AND FRACTURE TRACE ANALYSES OF CHLOR-ALKALI FACILITY

Berlin, New Hampshire

EPA Region 1

TS-PIC-20801101S
February 2008

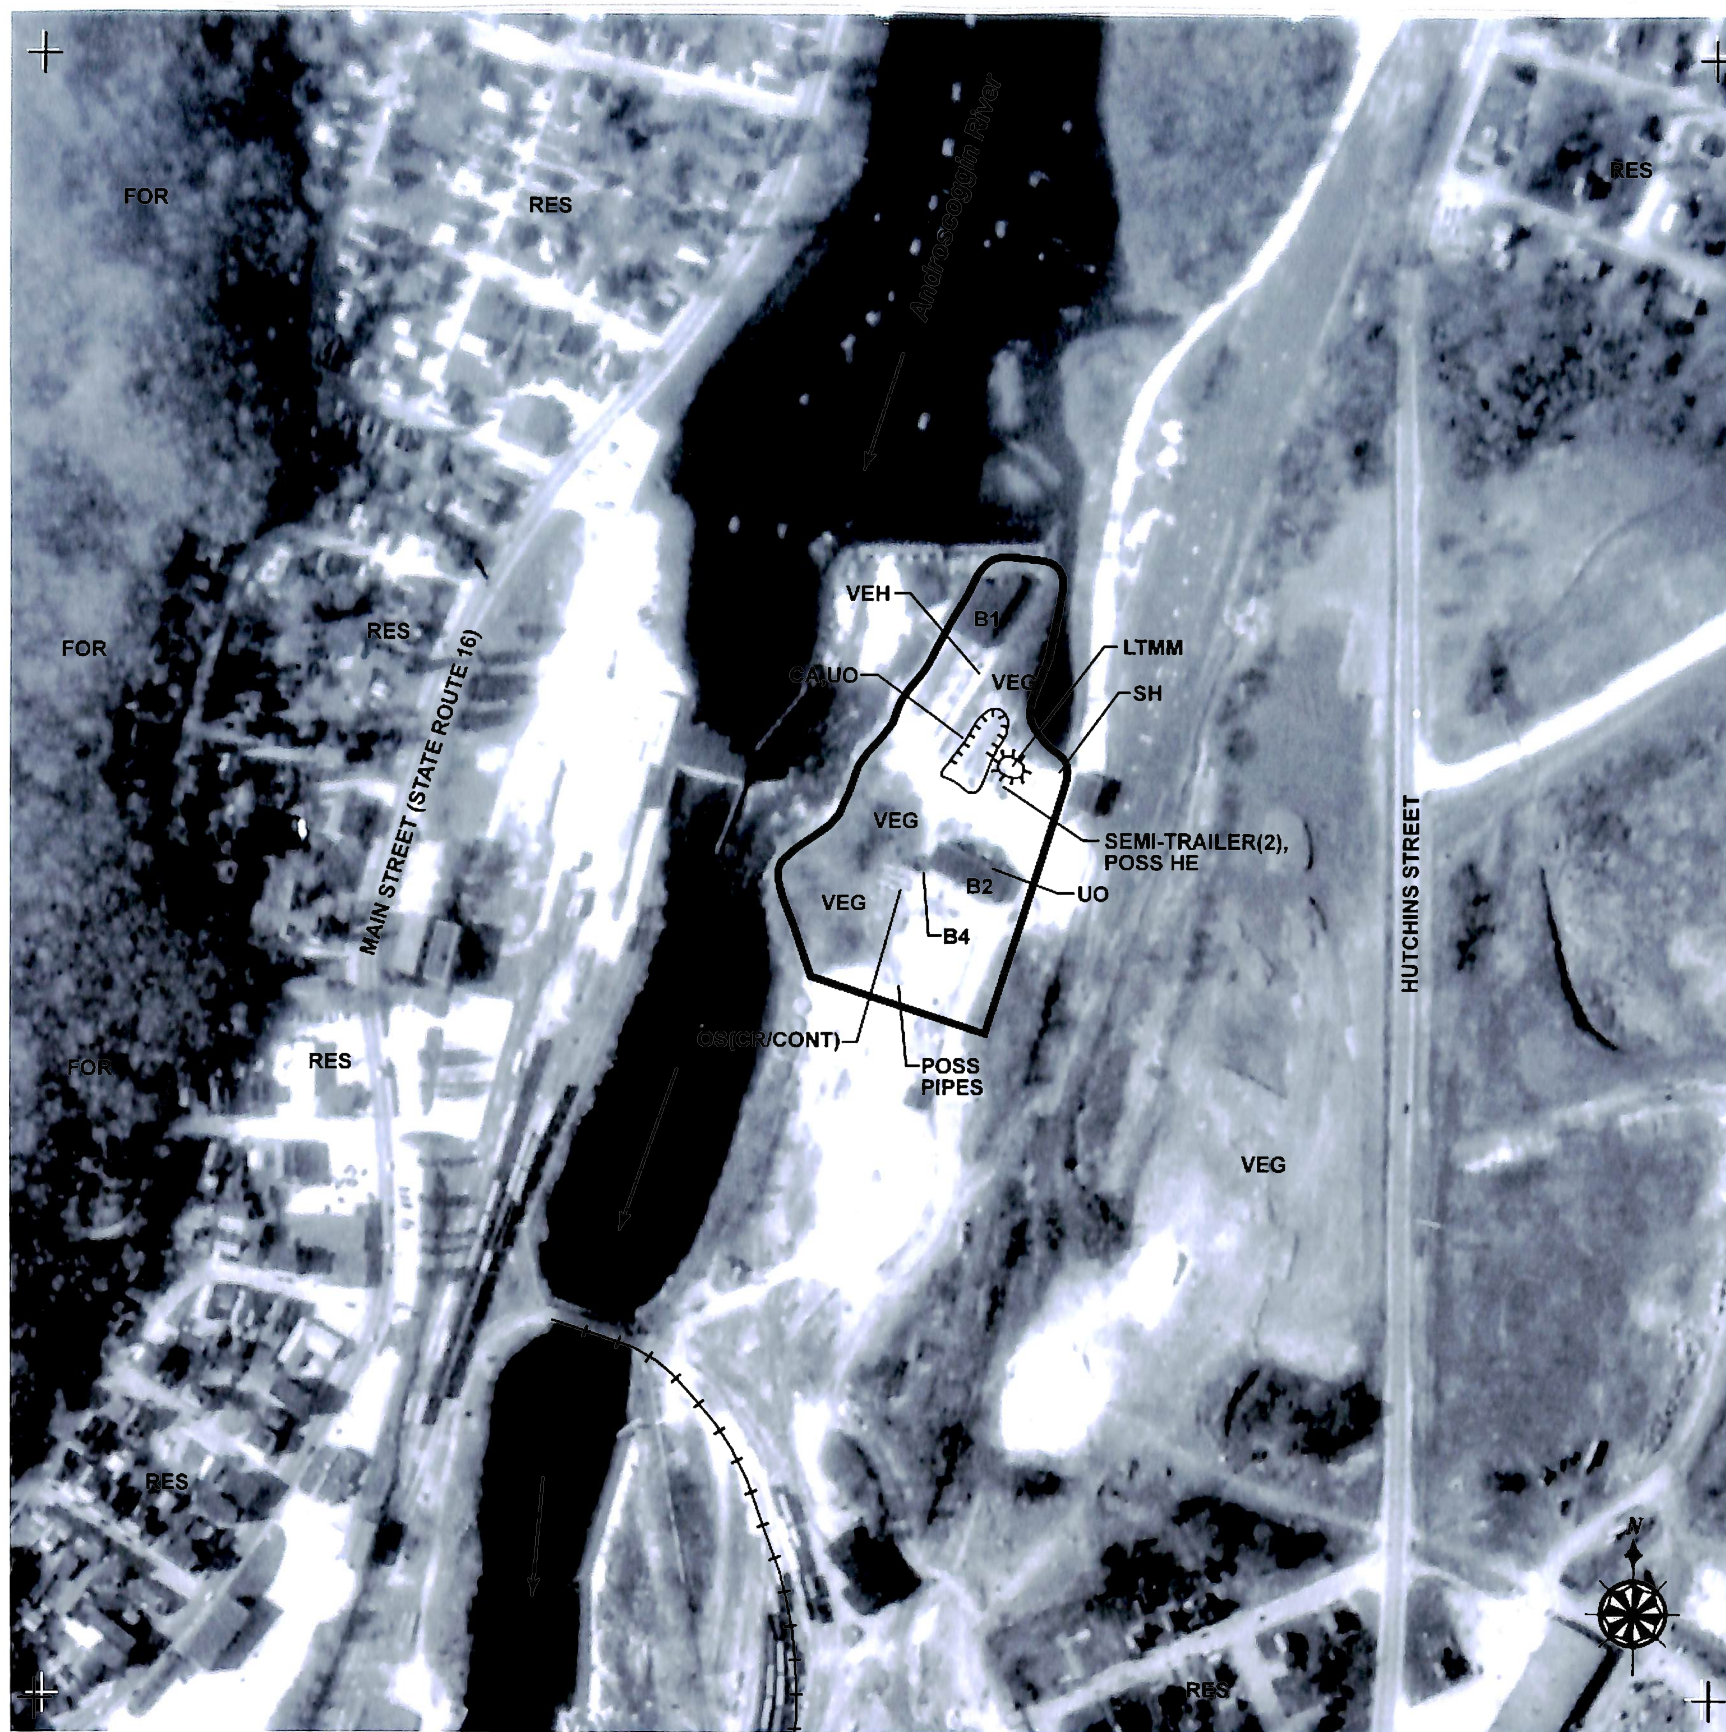
Figure 12. Chlor-Alkali Facility, May 14, 1994. Approximate scale 1:3,600.

MAY 14, 1994 (FIGURE 12)

The 1994 photographs have less resolution than other photographic coverages used in this report. Therefore, features visible on photographs from the other coverages may not be discernible on the 1994 photographs and the following analysis is not as detailed.

There are no changes noted to buildings B1, B2, B4 or the shed; however, all railroad lines have been removed from the site. Vegetation areas throughout the site appear unkempt. Two semi-trailers, possible heavy equipment (HE), and a vehicle are noted at the site. Near the trailers are light-toned mounded material and a large cleared area (CA) which forms a depression. Several small, unidentified objects are noted within this cleared depression. Near buildings B2 and B4 are a larger unidentified object and an open storage area where crates or containers are neatly arranged in three evenly spaced rows.

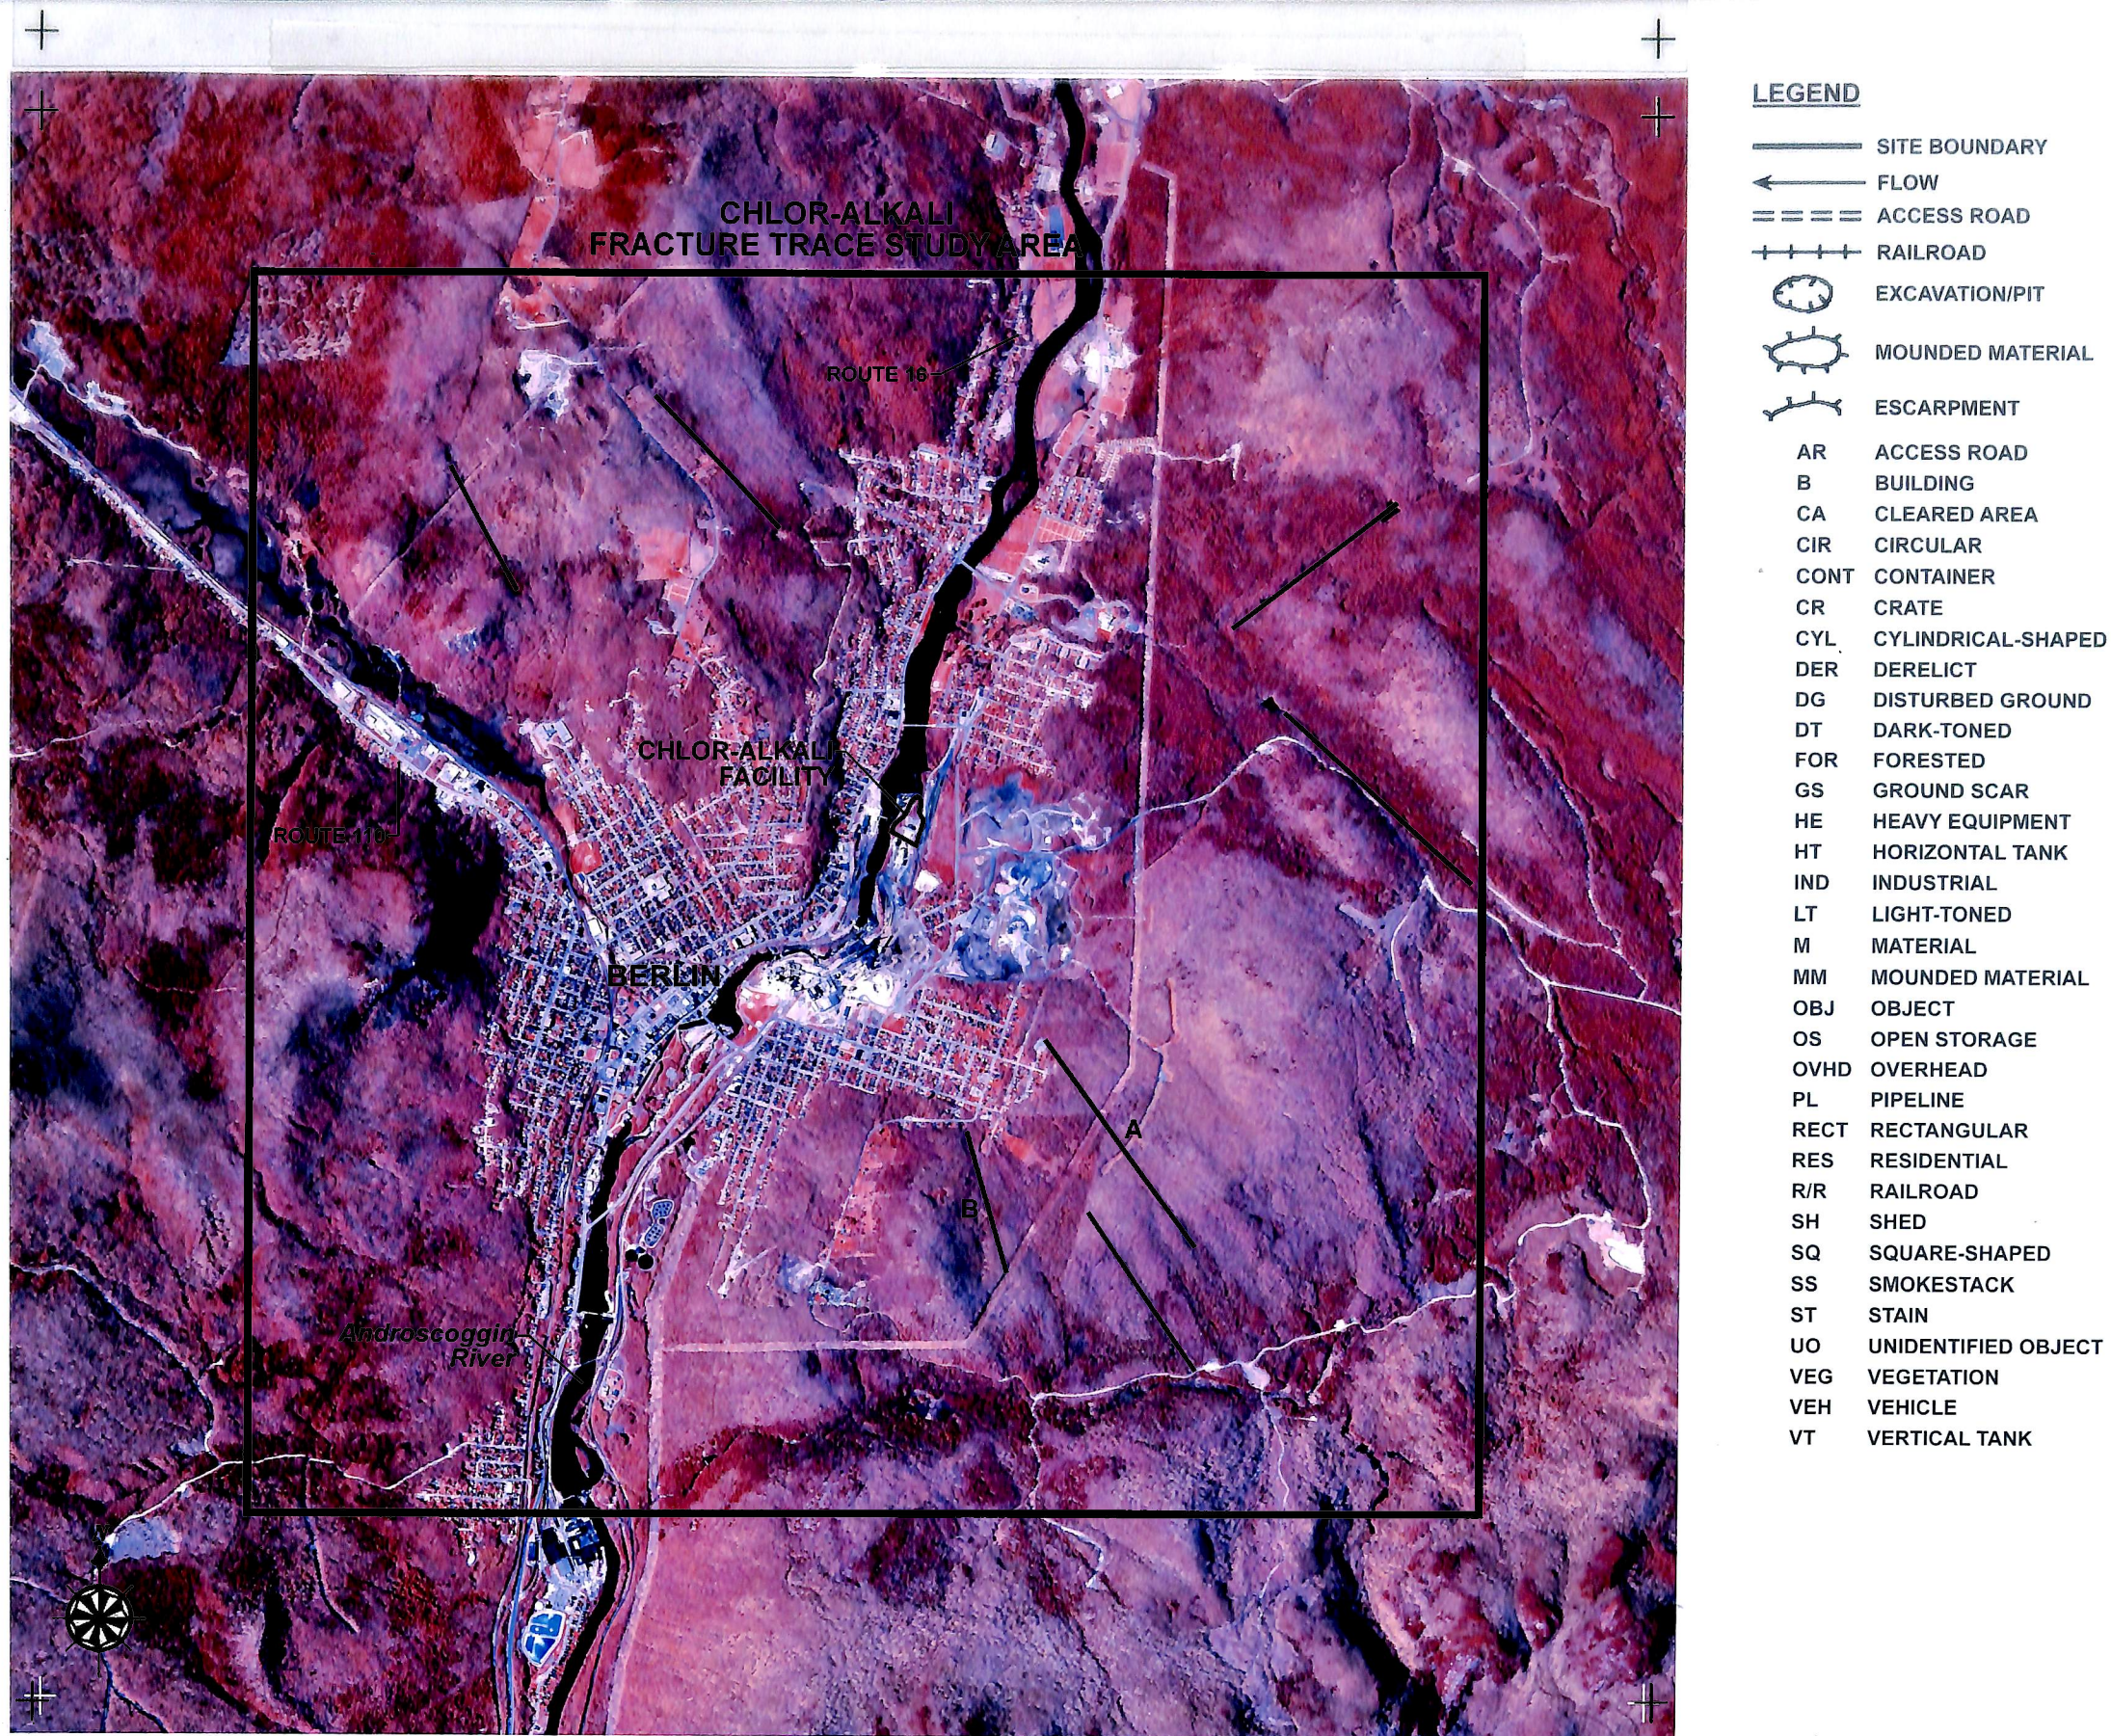
Figure 13. Chlor-Alkali Facility, fracture trace analysis, May 13, 1986.
Approximate scale 1:35,110.

The fracture trace analysis was conducted using 1964 large-scale photographs (1:18,000 scale), 1982 medium-scale photographs (1:40,000 scale), and geologic literature describing the area. A total of seven (7) fracture traces were identified and are presented on an overlay to a print produced from a 1986 photograph (see Figure 13). Two lineaments are presented in a study by Degnan, J.R., et al., (2005). One lineament is located north of the Chlor-Alkali Facility along the east bank of the Androscoggin River and the other in the upland area southeast of the facility. These two lineaments were identified using high altitude aerial photography with an approximate scale of 1:80,000 (Degnan, J.R. et al., 2005). An unsuccessful effort was made to corroborate the location of these two lineaments on the medium- to large-scale photographs used in this report. The lack of success may be attributable to the differences in the scale of photography used in the separate studies.

All of the seven fracture traces identified in this fracture trace analysis are situated in the upland portion of the study area and are underlain by Ammonoosuc Volcanics. Urban development along the Androscoggin River valley has obscured or destroyed any evidence of fracture traces in the area underlain by the Oliverian Plutonics. None of the seven fracture traces were identified extending across the interface between the two bedrock units (Oliverian Plutonics and Ammonoosuc Volcanics) underlying the study area. Therefore no fracture trace induced hydrologic connectivity between the bedrock units can be inferred from this analysis. However, if fracture traces "A" and "B" (see Figure 13) are extended to the northwest into the Oliverian Plutonics of the urban developed lowland area, the two extended traces intersect at the Androscoggin River near the southwest corner of the Chlor-Alkali Facility. This intersection point may possibly identify a zone of fractured bedrock that preferentially directs ground-water flow toward the facility.

Caution, however, should be exercised if the fracture traces identified in this analysis and annotated on Figure 13 are to be used for determining the placement of groundwater monitoring wells. Differences of a few meters can determine whether or not a well is located on a given fracture trace. Thus, it is recommended that the geologic field personnel tasked with determining the placement of the wells utilize stereo diapositives and photographic interpretive equipment as part of their field operations.
